My ST-1100 Stopped Working

Link: https://help.wextelematics.com/troubleshooting/my-st-1100-stopped-working/ Last Updated: July 26th, 2016

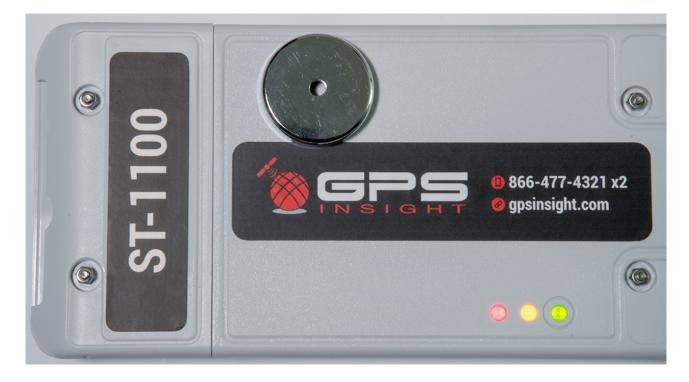
1. Place the CUP magnet on the device, just above the GPS Insight sticker and position it between the globe icon and the letter G.

The placement of this CUP magnet is crucial to making this reset process work. Place it exactly as noted in the instructions and shown in the image below.

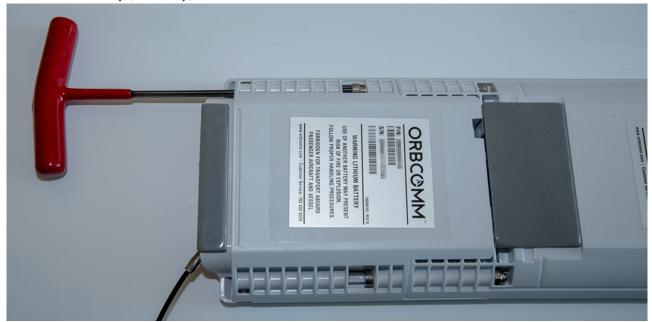
1. Use a 9/64 HEX key (Allen key) to loosen the 2 HEX screws.

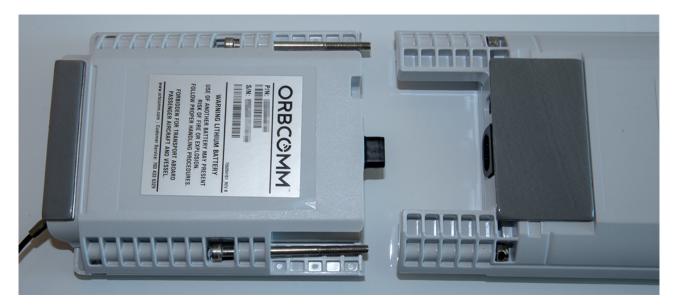
2. Pull apart the two pieces, and collect the two nuts. Place the two nuts in a safe place so they are not lost.

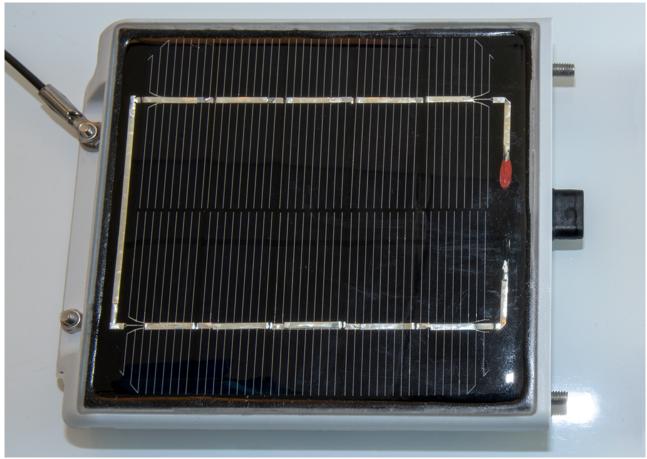
3. Place the solar panel portion of the device in the sun for three to four days.

After about four days, the device will reset and will be ready to reconnect and reinstall. When you run the Performance Report again, the device should report at or above 7.2V.
